# HP 4952A Protocol Analyzer

Repair.

Bernd Längerich, 21.11.2022 v23

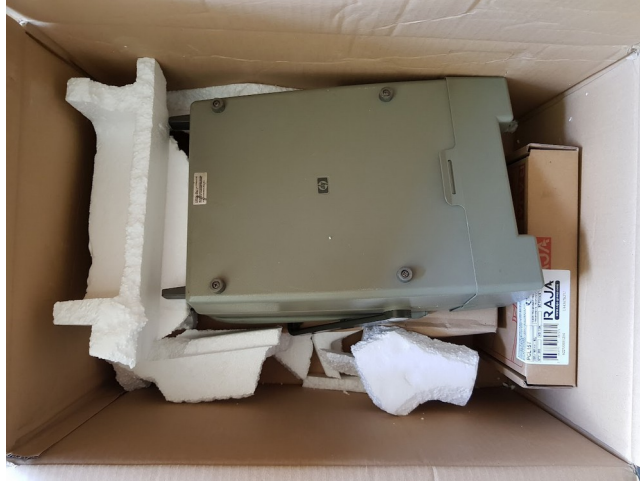
*Figure 1: Poorly packaged instrument...*

Lately a HP 4952A was acquired on ebay by me. It came in a box and was rattling inside. The seller did a very poor job on packing up the instrument in a suitable box. Oh boy, that was not a good start...

Fortunately the instrument seemed to be undamaged, no shattering glass, no dents or cracks. I have to thank Hermes, they seemed to take good care of the box.

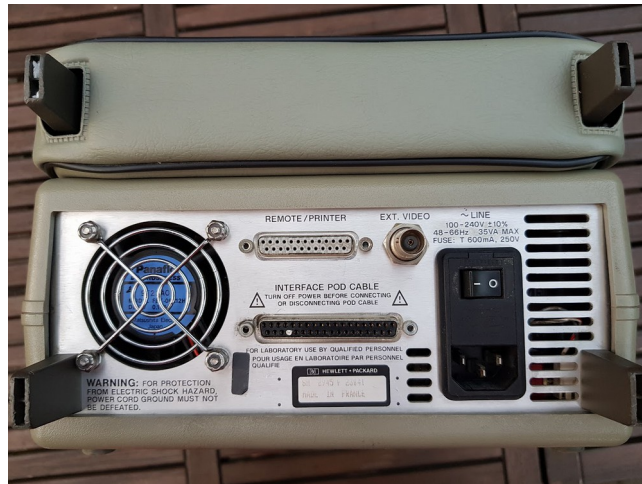
*Figure 9: Rear view with combination of IEC plug, filter, fuse and switch*

But the filter made by Schaffner already leaked, so I removed the filter section and rewired. I have to find a suitable replacement mains socket, filter, fuse and switch in that form.

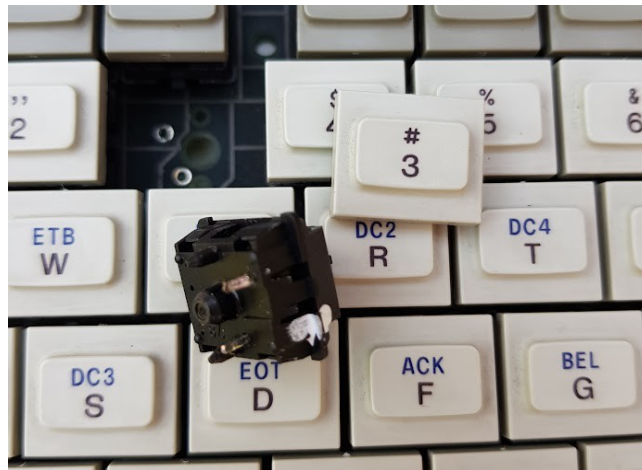
*Figure 10: Desoldered key*

Testing with the boards installed back, I found that all keys are working except the "3" key. So I had to dismantle the keyboard. All keys are made by Cherry, so I unsoldered the key, opened it and gave it a good clean.

After reassembling it, it tested fine, so I resoldered it.

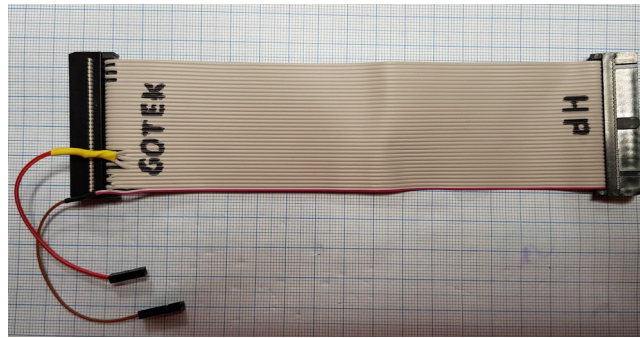
Figure 14: Special connection cable

To connect the Gotek drive without modifying it, I assembled a special wire harness, using two 34pin IDC connectors and a ribbon cable. From the second side to the Gotek, I modified the cable as follows:

1. Cut Pin 1 and use a single crimp contact ("Dupont") to jumper it to pin SWCLK of the Gotek (right above the power connector)
2. Cut pins 3, 5, 7, 9, 11 and connect them to a single crimp contact to connect to the power connector (+5V)
3. Cut pins 29, 31, 33

This disconnects some of the odd numbered pins from ground as they are used by HP for power supply and disk change reset.

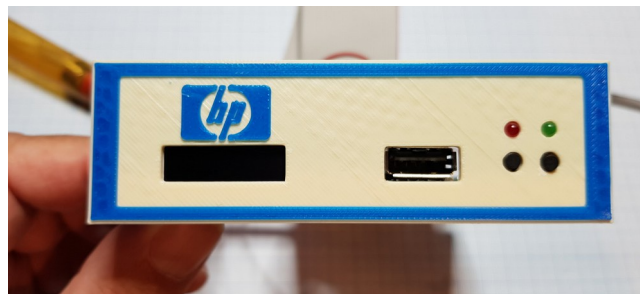
*Figure 15: hp branded front*

The Sony floppy drive is higher than an usual PC floppy drive. The Gotek form factor follows the now used PC like floppies drives, so I had to mount the drive with a bracket inside the HP. As the drive was black, I was not satisfied with the optics and decided to create a new front.

On Thingiverse there is a Gotek bracket and front for the Amiga computer, that uses the same form factor. I modified the design to include a HP logo of that time and printed the front with two colors.
